EMDF Comments Primarily Related to the Site Groundwater Characterization Fact Sheet
Due DOE June 7, 2022

Subject: Comments primarily related to the Site Groundwater Characterization fact sheet

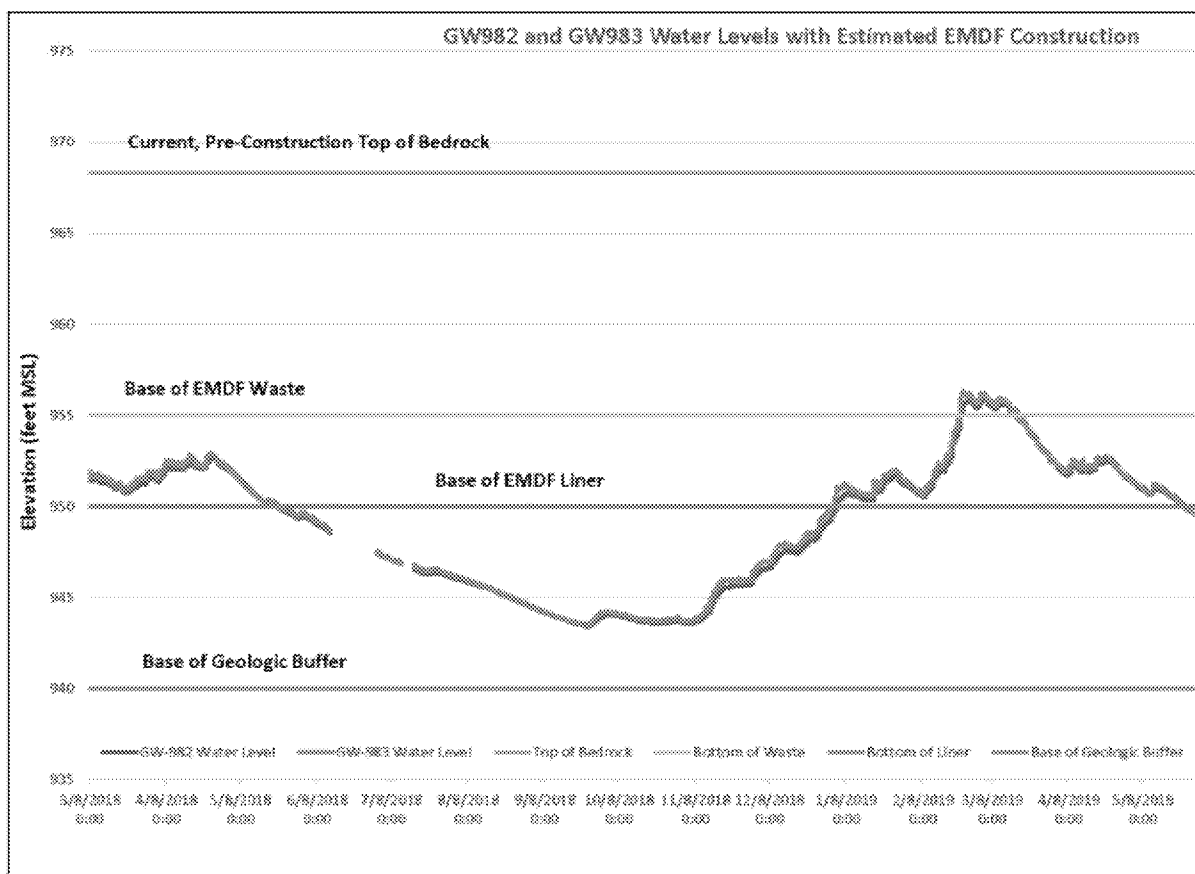
The two well pairs in areas of proposed excavation on the knoll for proposed Cells 1 and 2, under current conditions groundwater conditions show groundwater levels are sufficient to impact the geologic buffer year round and to impact the geomembrane liner and rise into the waste zone at certain times of the year. Please see the following figures. Top of bedrock in the following figures was estimated from borehole log auger refusal in borehole logs included in TM#2.

Deep Piezometer GW-982 screened from 102.1 - 112.1 ft-bgs (elevation 913.5 - 903.5 ft)
Shallow Piezometer GW-983 screened from 79.1 - 89.2 ft-bgs (elevation 936.4 - 926.4 ft)

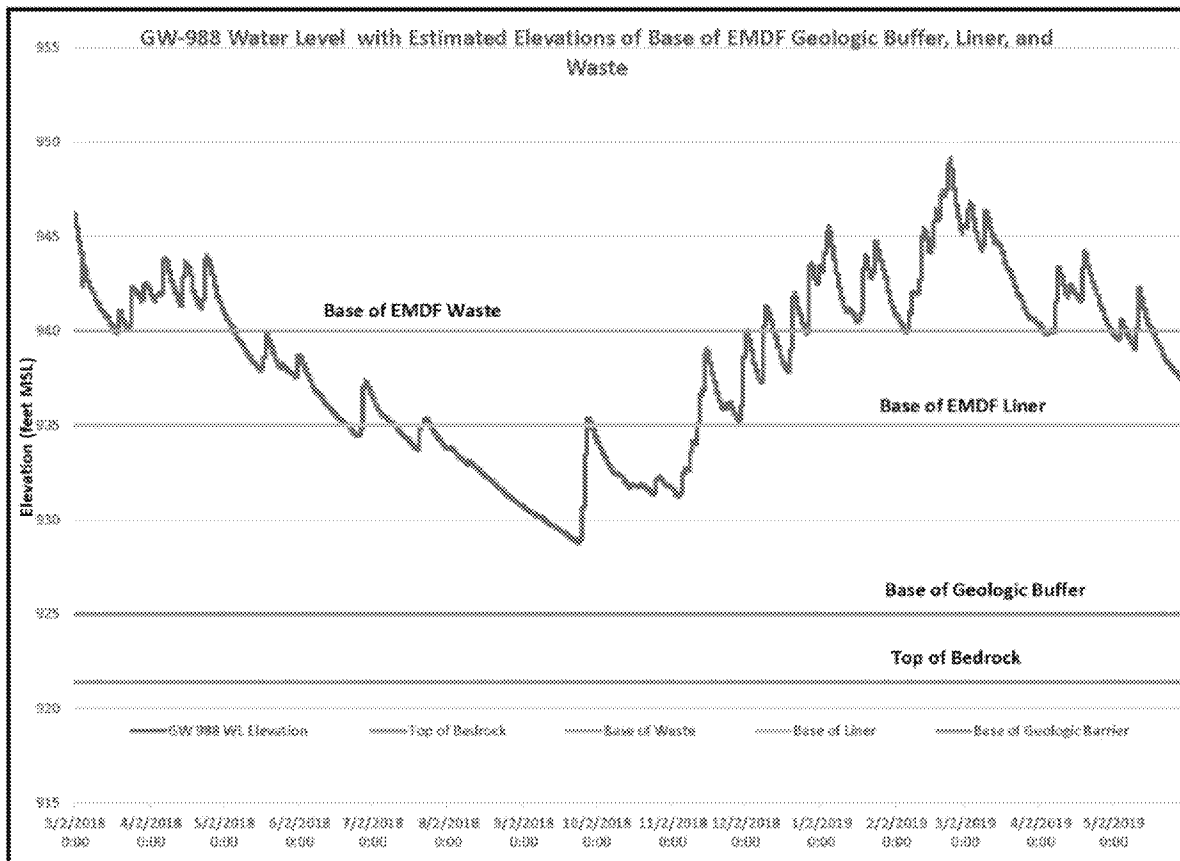
Deep Piezometer GW-988 screen interval 61.9 - 71.9 ft-bgs (elevation 895.1- 885.1 ft)
OREIS does not include monitoring data for this period for shallow paired GW-989

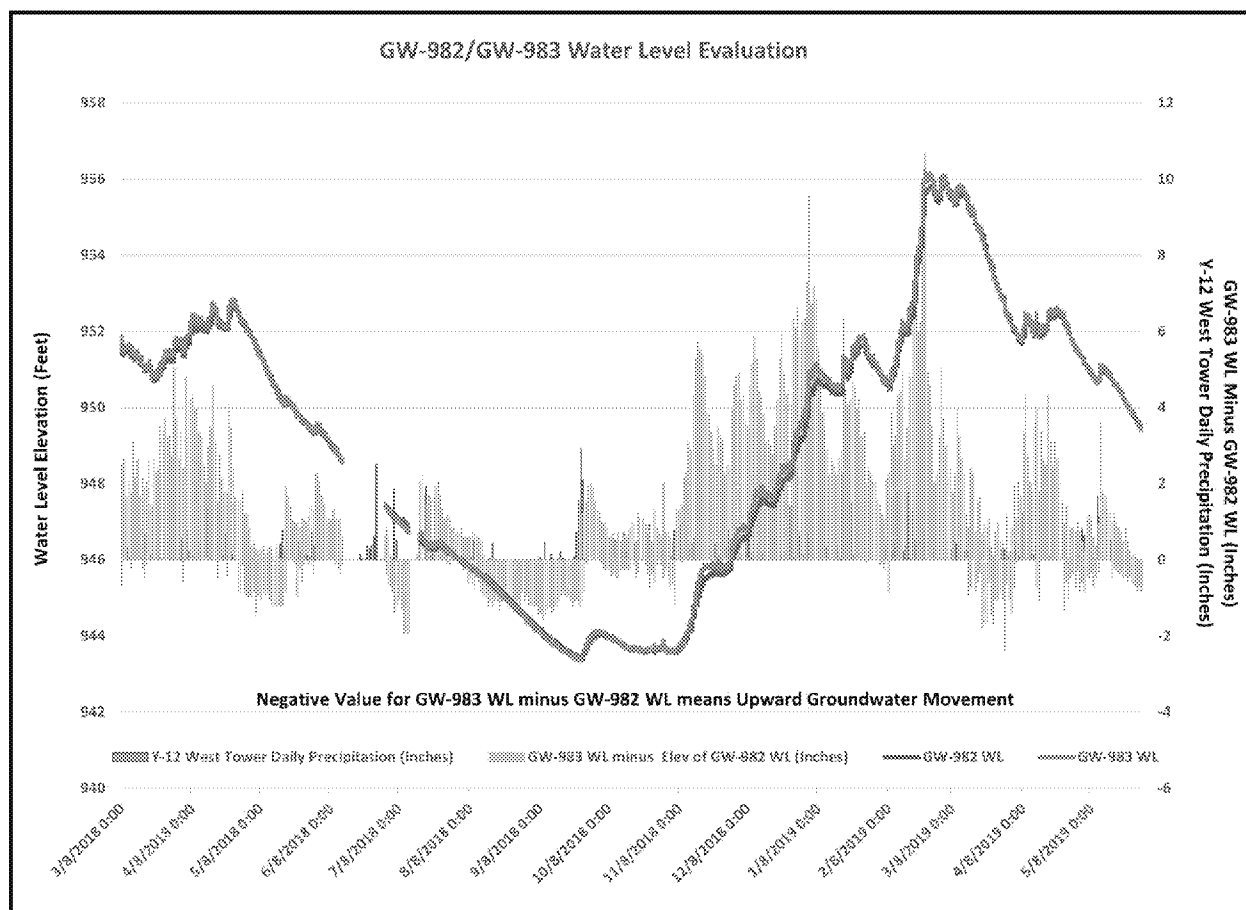
The following figure derived by comparing water level data collected for TM-2 and available in OREIS for deeper and shallower piezometers GW-982/GW-983, shows that in addition to rising groundwater in the GW-982/GW-983 area during September 2018 dry conditions noted in TM-2 Table 7.3, under current conditions rising groundwater based on water levels was also recorded in TM-2 data up to an elevation of about 955 feet.

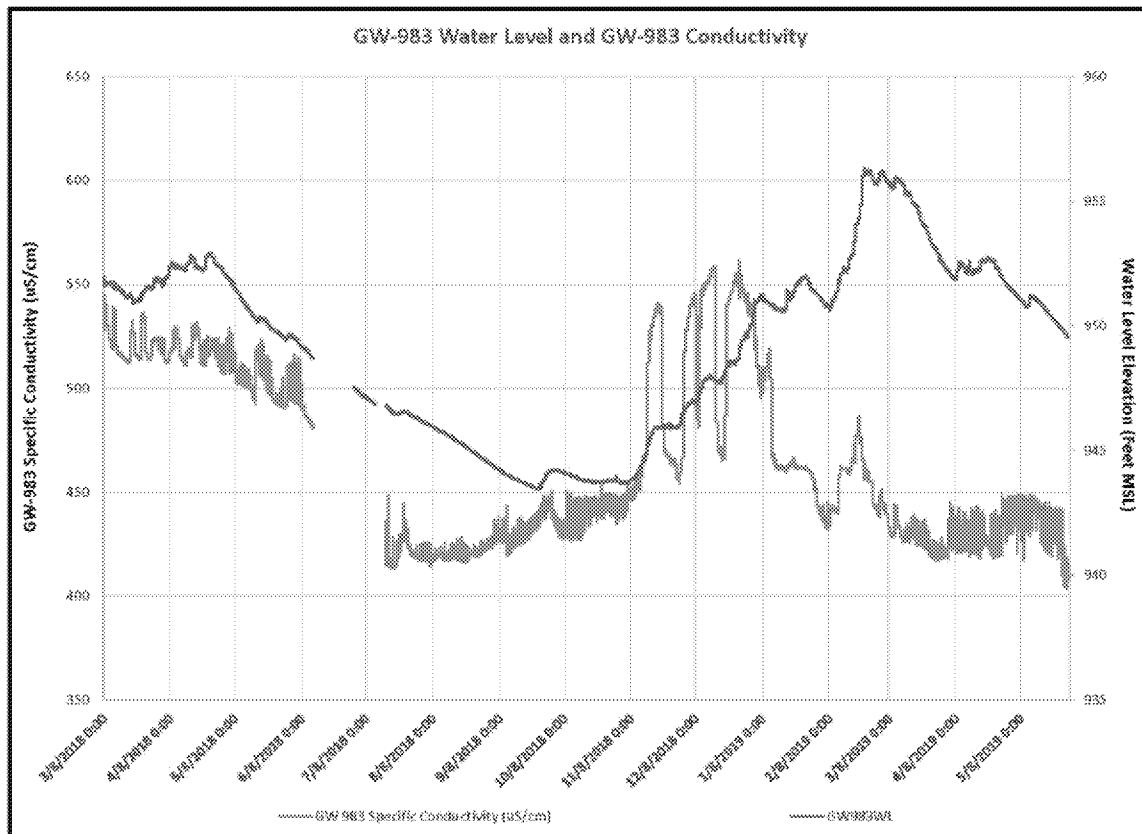
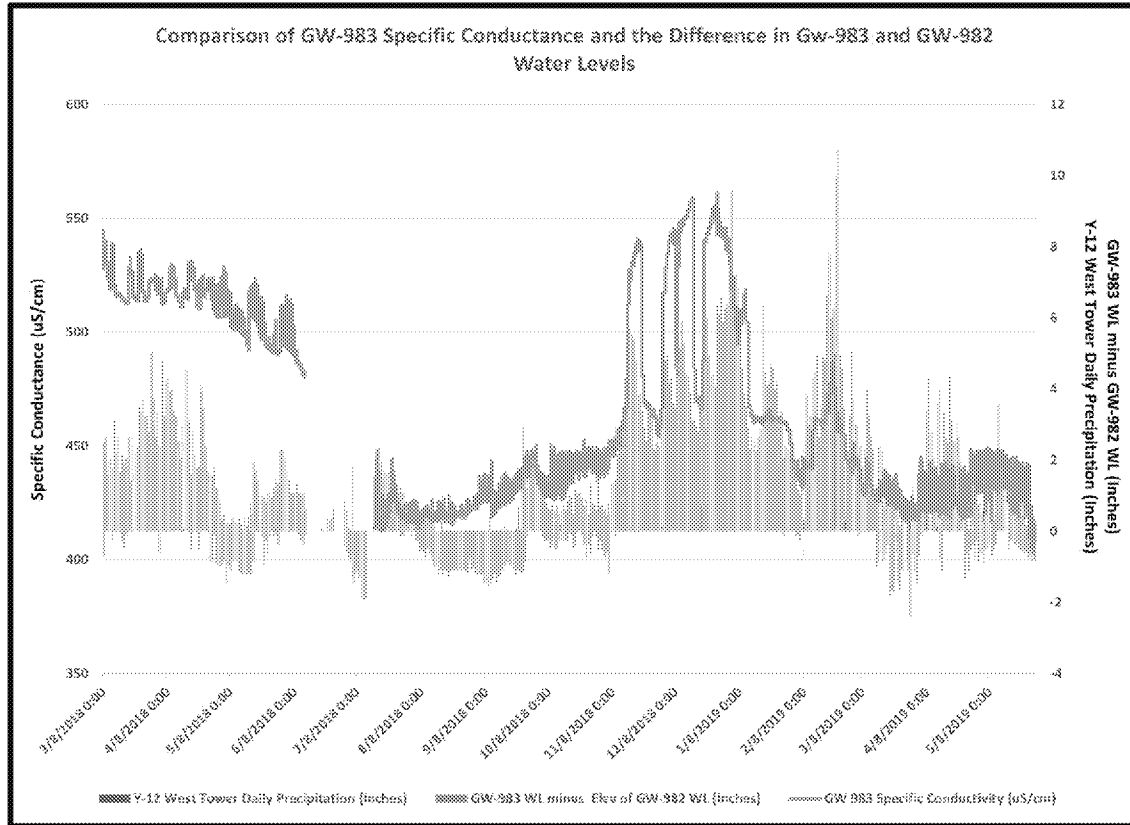
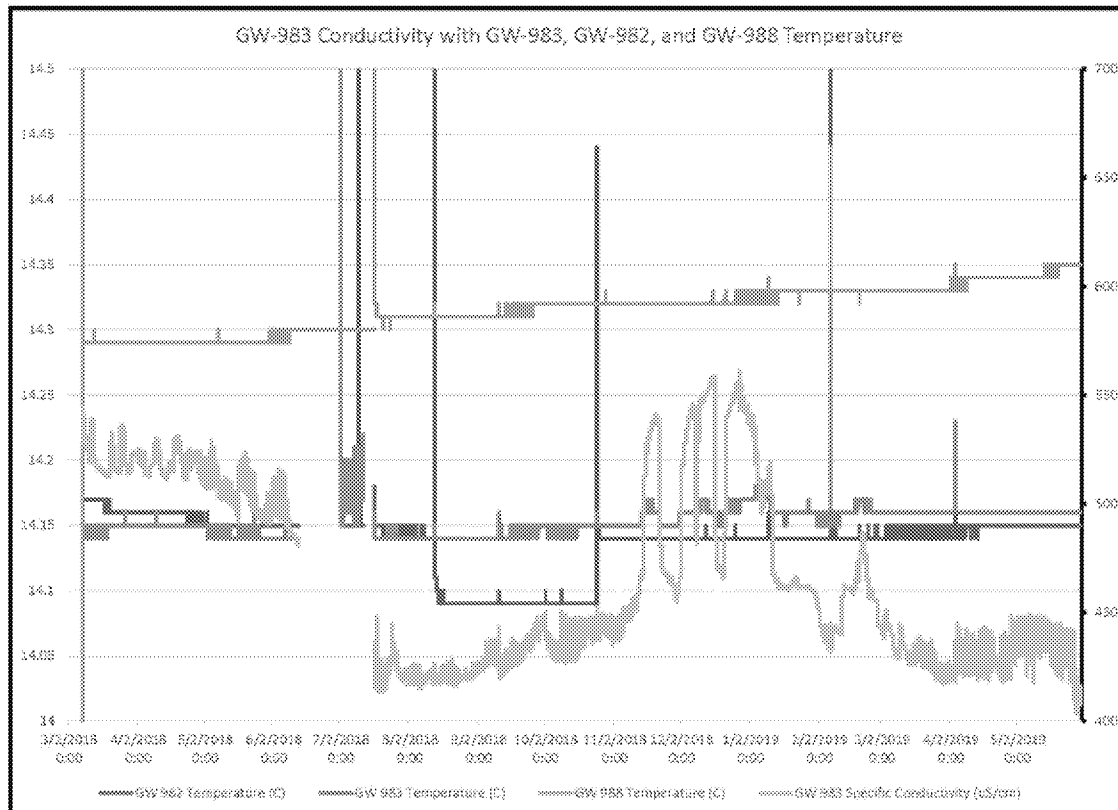
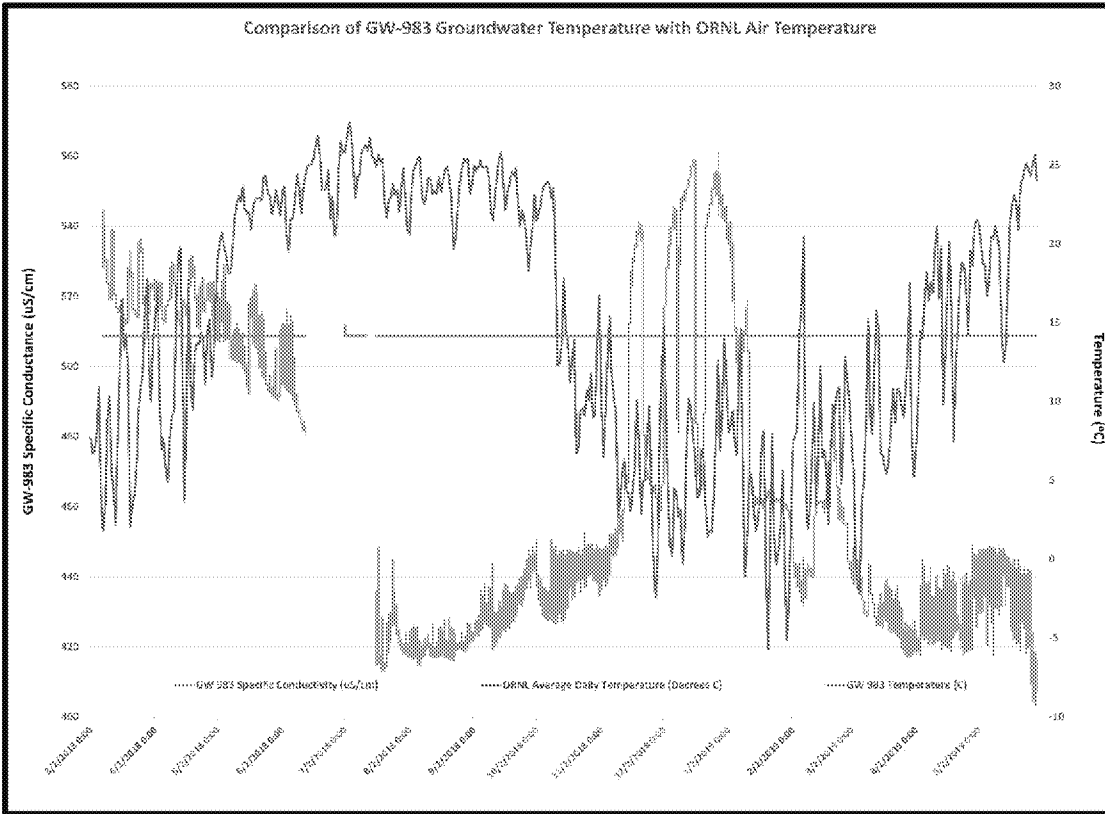
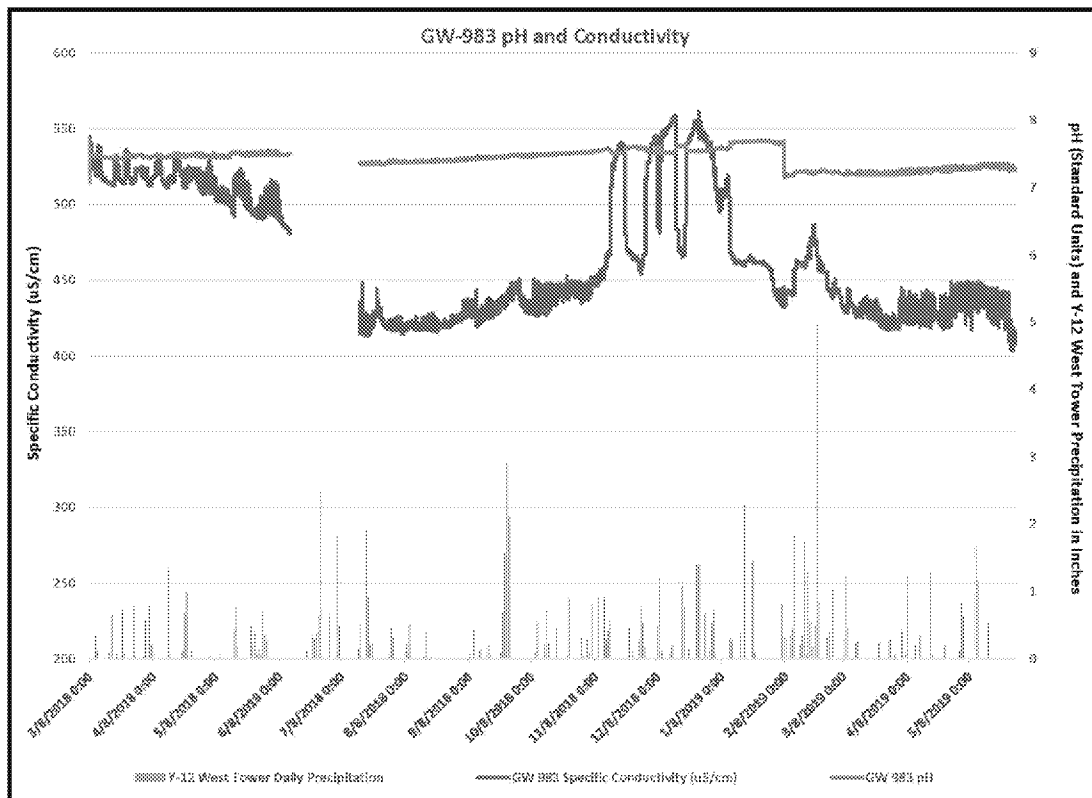
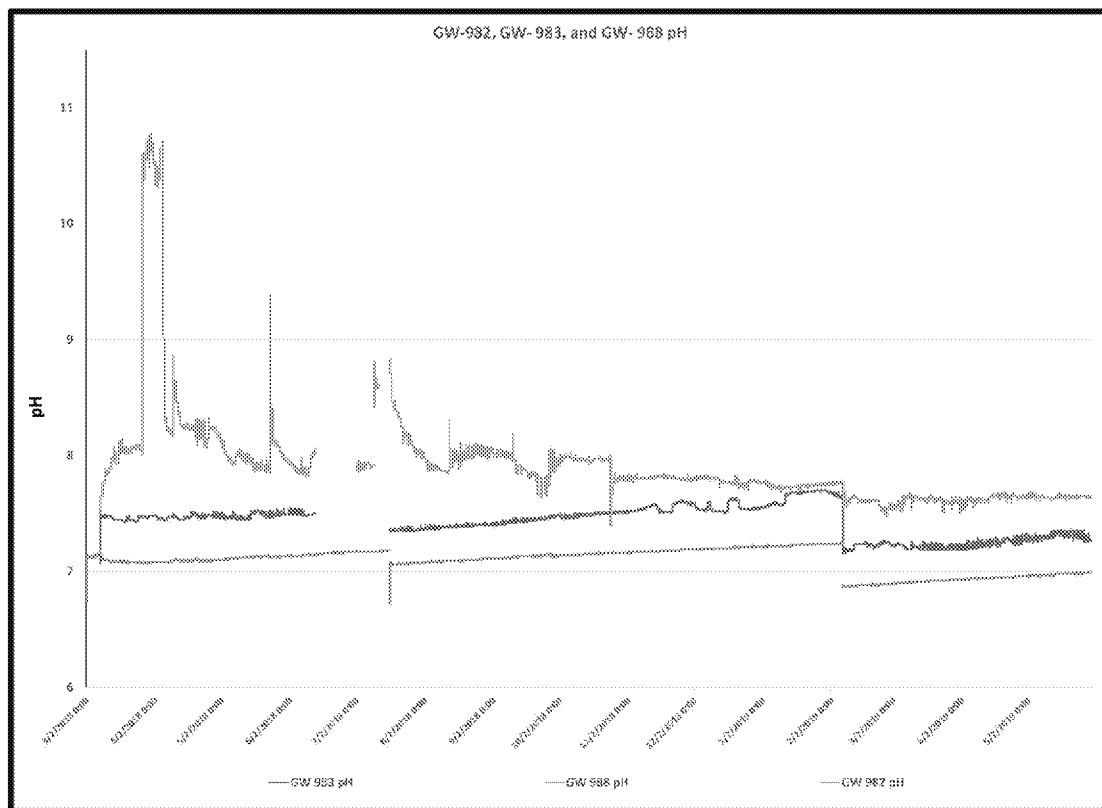
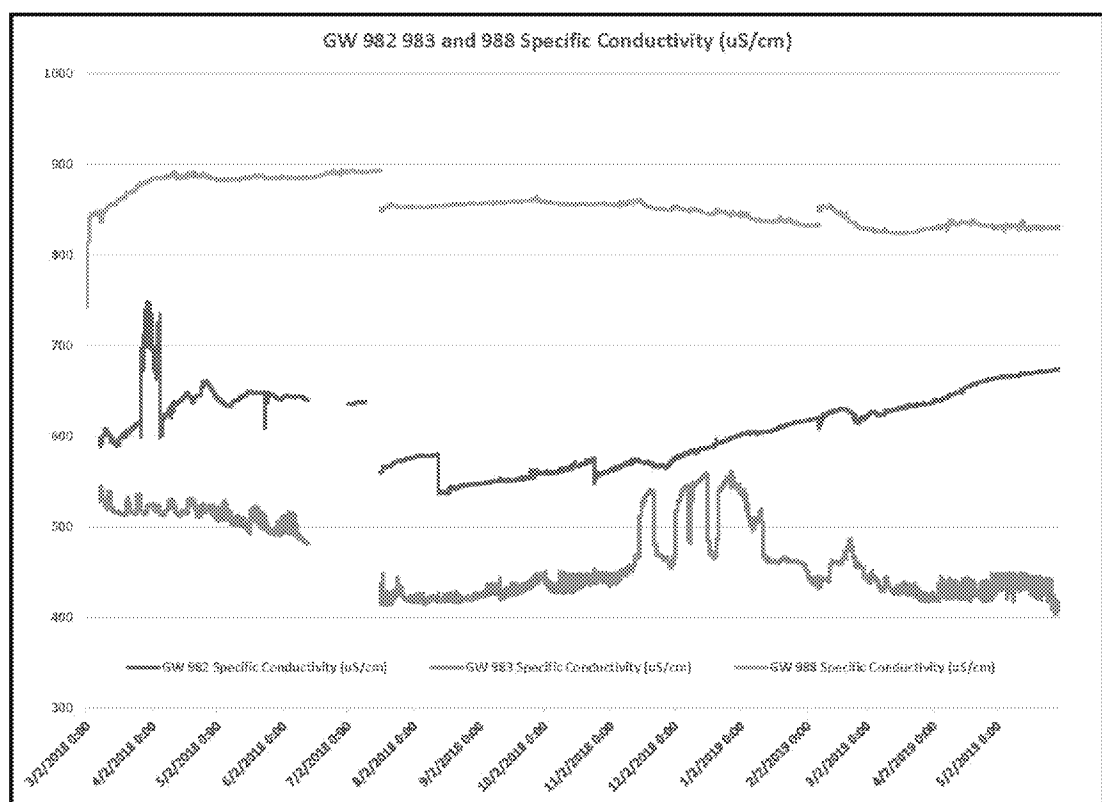
- 4) In addition to water level data, electrical conductivity, pH, and temperature data were also collected for TM#2. The following figures include:
 - a) GW-983 electrical conductivity overlain on GW-983 water level;
 - b) GW-983 electrical conductivity (specific conductance) overlain on the difference of water levels derived by subtracting the elevation of the water level in GW-982 from the elevation of the water level in GW-983;
 - c) GW-983 electrical conductivity overlain over groundwater temperatures measured in GW-983, GW-982, and GW-988;
 - d) Comparison of GW-983 groundwater temperature with air temperature measured at ORNL;
 - e) GW-983 groundwater electrical conductivity overlain on GW-983 pH;
 - f) Comparison of GW-982, GW-983, and GW-988 pH; and
 - g) Comparison of GW-982, GW-982, and GW-988 electrical conductivity (i.e., specific conductance).

- Increased electrical conductivity (i.e., specific conductance) in GW-983 observed from about November through March is real and is generally associated with an increase in groundwater temperature and a decrease in groundwater pH.

- November through March are colder months and both air temperature at ORNL and groundwater temperature for deeper piezometer GW-982 have temperatures lower than the high conductivity groundwater entering GW-983. Increased temperature of groundwater associated with the higher electrical conductance groundwater during late fall and winter shows the source of the influx of higher electrical conductance groundwater is neither GW-982 nor infiltrating rainwater.

- Deeper piezometer GW-982 also has a higher pH than GW-983, so again it's not the source of lower pH groundwater entering GW-983.
- The higher electrical conductivity groundwater entering GW-983 appears more like groundwater measured in GW-988 than either rainwater or GW-982.

This analysis concludes the higher electrical conductivity, lower pH, higher temperature groundwater that entered GW-983 during late fall and winter 2018/2019 is real, not bad data, and was neither infiltrating rainwater nor GW-982 groundwater. Where electrical conductivity begins to drop off in January and February may be due to dilution from infiltrating rainwater.

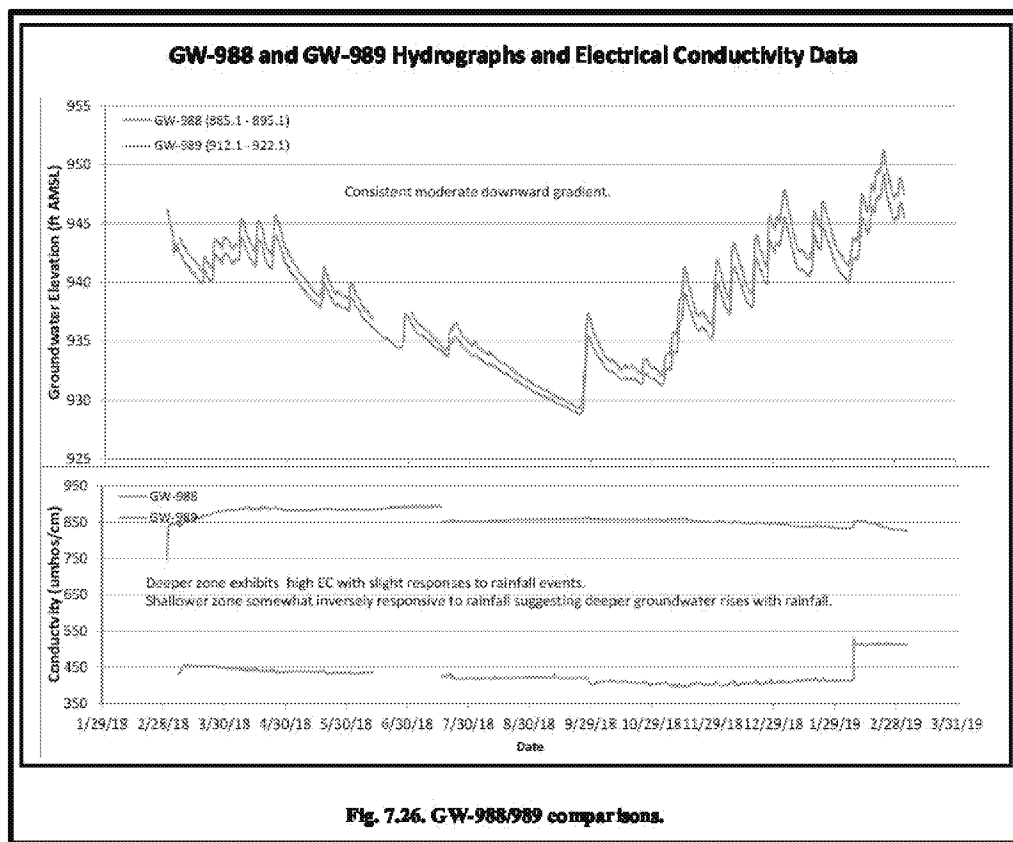
- 6) Piezometer pair GW-988 and GW-989 possibly drilled through a fault(s). Borehole descriptionsⁱⁱ of bedding turning from a 45-degree dip to near vertical with additional discussion of slickensides perpendicular to bedding, some limestone beds being highly deformed to almost brecciated, and possibly slightly overturned beds appear to indicate faulting. In this case both deep piezometer GW-988 and shallow piezometer GW-989 are screened in or near potentially faulted intervals. Shallow piezometer GW-989 sand pack also appears to across the saprolite bedrock contact allowing shallow groundwater at the saprolite bedrock contact to enter the piezometer. TM-2 also includes the following figure with a statement suggesting deeper groundwater rises with rainfall.

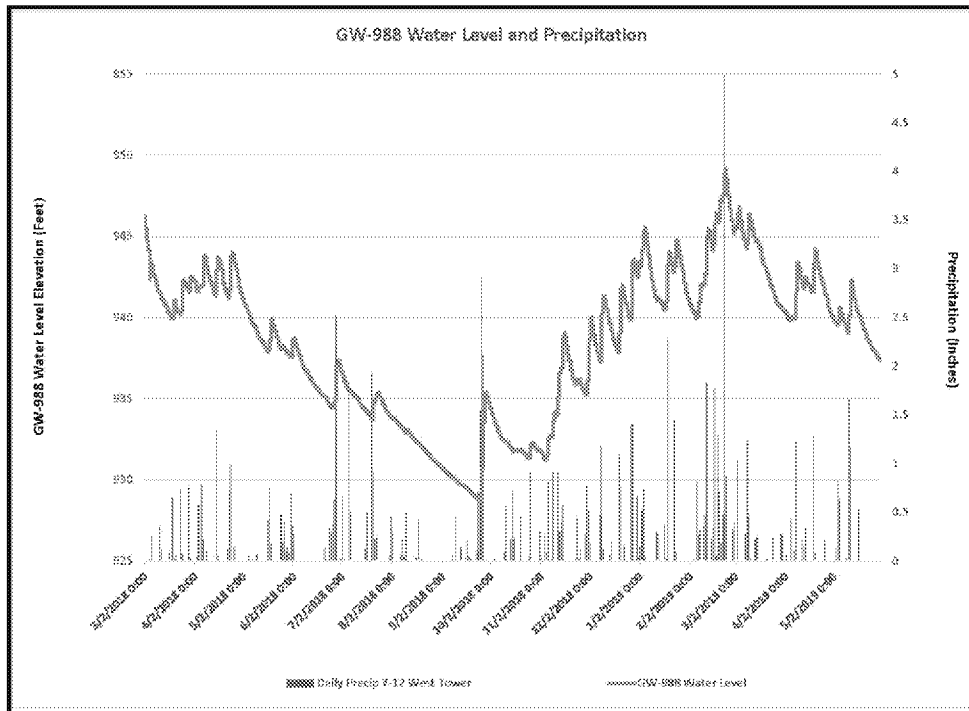
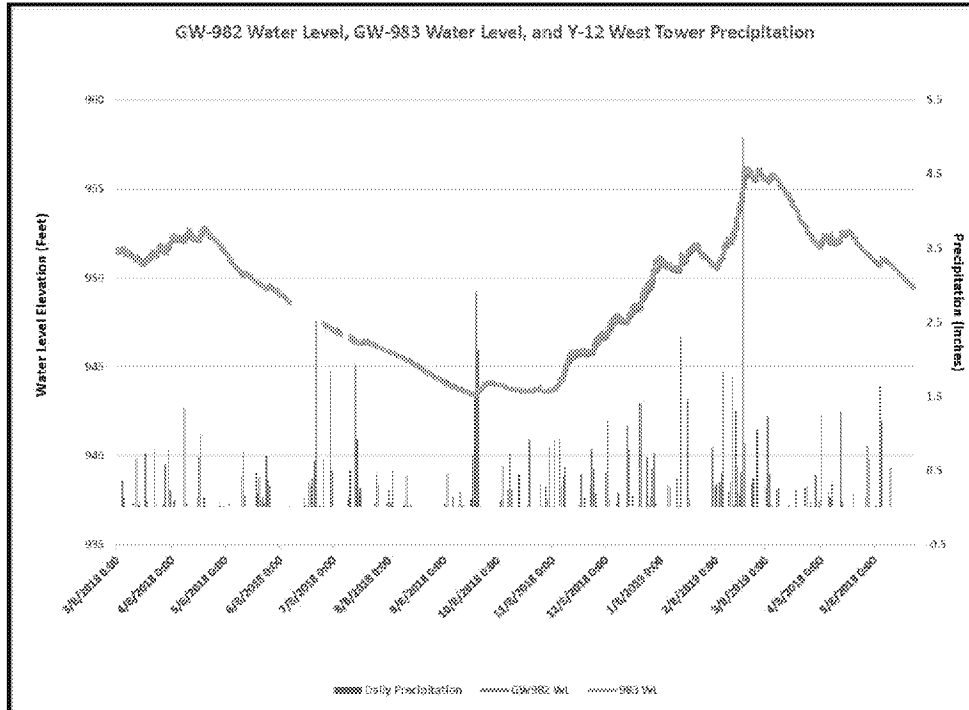
- 7) The Site Groundwater Characterization fact sheet correctly noted the water level response to rainfall. However, rainfall response in GW-988 was quick and response in GW-982/GW-983 was delayed.
